Annual Inspection Report

Double Springs-Winston County Airport

ANNUAL INSPECTION REPORT

DOUBLE SPRINGS-WINSTON COUNTY AIRPORT
DOUBLE SPRINGS, ALABAMA

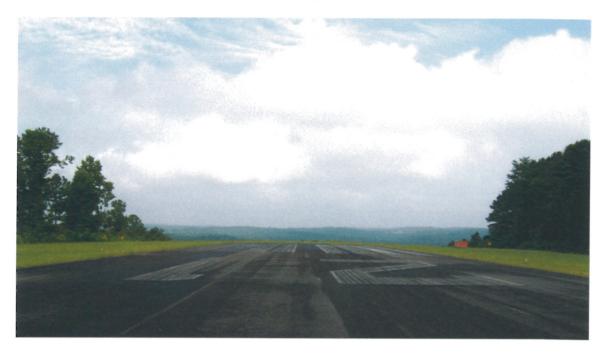
Photo #1 - Runway 21 Approach/Departure Path

- Runway 21: No obstructions (See Photo # 1 and Appendix 2).
- Runway 3: Trees identified as Tree # 8 and Tree # 9, violate the 20:1 approach/departure path (See Photo # 2 and Appendix 3).

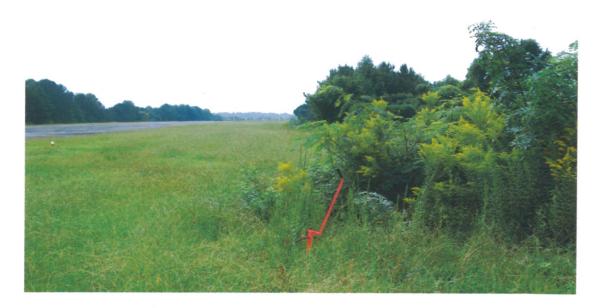
The primary surface is violated by brush growing within its boundaries on northwest side of runway 21 (See Photo # 3 and Appendix 2)

All brush and vegetation must be removed from within the boundaries of the primary surface.

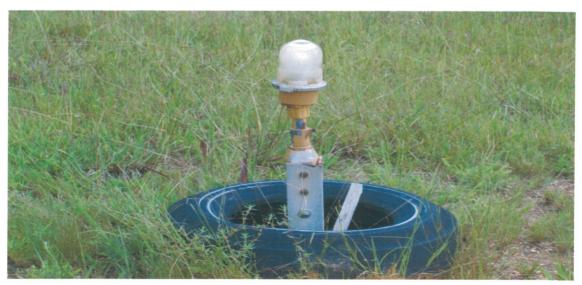
The grade of the runway safety area for both ends of the runway is short
of the required 200 feet. Runway 21's safety area is 120 feet while
runway 3 is 150 feet (See Appendix 2). Also the runway lights are
installed using non-frangible angle iron stakes that extend above the
surface (See Photo # 4 and Appendix 3).

- Construct the required 200 foot long by 120 foot wide Safety Area as shown in Appendix 1. The thresholds of the runway must also be displaced to provide a 200 foot long cleared area if construction is not completed. The displacement of the threshold will require that the threshold lights be moved to the point of displacement and the runway marked according to the provisions of FAA AC150/5340-1J "Standards for Airport Markings".
- Proper installation of the runway lights is provided in Figure # 1 below.

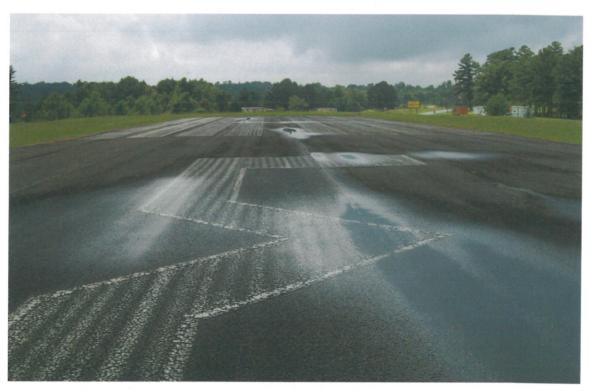
• The runway markings are faded (See Photo # 5).

Markings should be repainted in accordance with FAA AC 150/5340-1J.

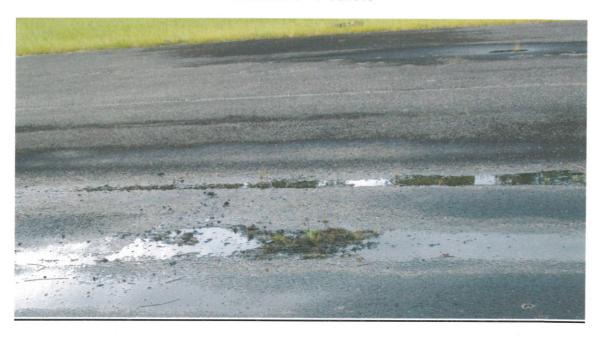
The overall condition of the airport pavement surfaces is in fair condition.
There are very few cracks, but widespread moderate raveling and two
areas where the pavement has failed and potholes are developing (See
Photo # 6).

A new surface treatment or thin overlay will be needed in the near future; however the localized potholes should be excavated and the surface rebuilt immediately.
